Geotechnical Study on Ground and Masonry Structures in Angkorfor Safeguarding Monuments( Dissertation\_全文 )

Iwasaki, Yoshinori

2001-11-26

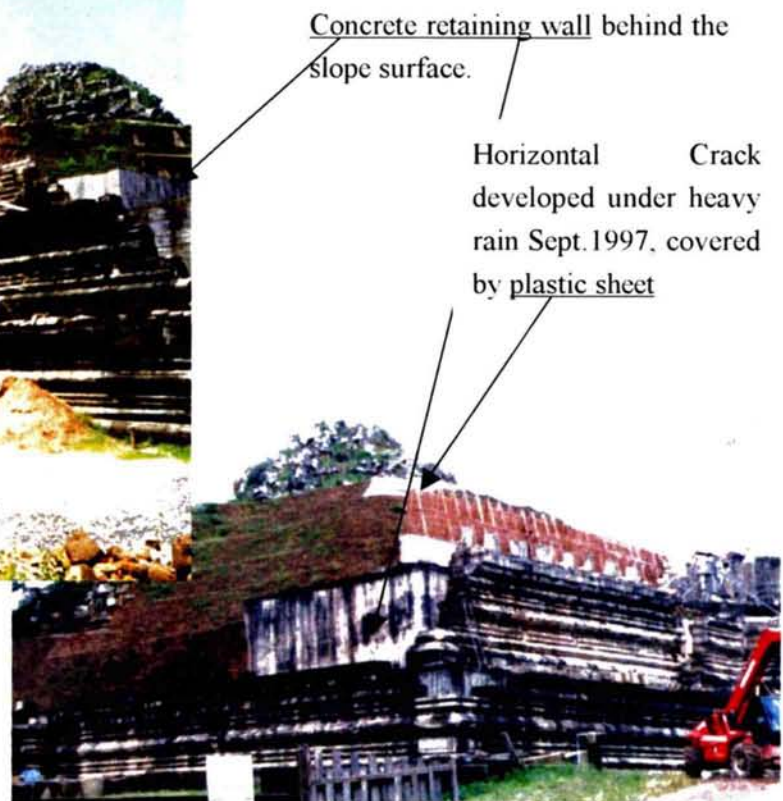
Photo 2-4 Crack appeared on top of the filling slope (photographed in October, 1997)

In September 1997, it was a heavy rain of about 200mm in one day, which caused not only a failure of embankment along the moat near the causeway to Angkor Wat but also resulted in horizontal crack of about 20m in length around top of the filling hill of Bapuhon. Fortunately, the width of the crack did not increase and the slope did not failed.

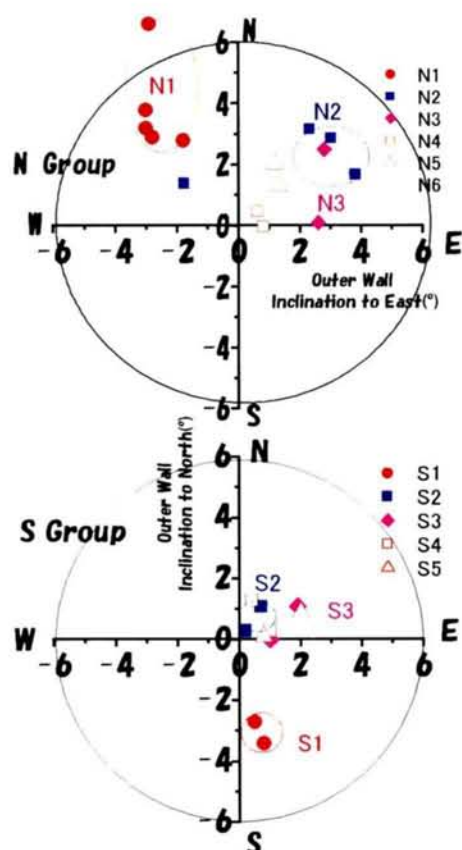
Fig.6-2 Distribution of Inclination of North and South Tower of Prasat Suor Prat

N1 tower has inclined towards north direction. The maximum inclination of 6.6 degrees to north is found for N1 tower.

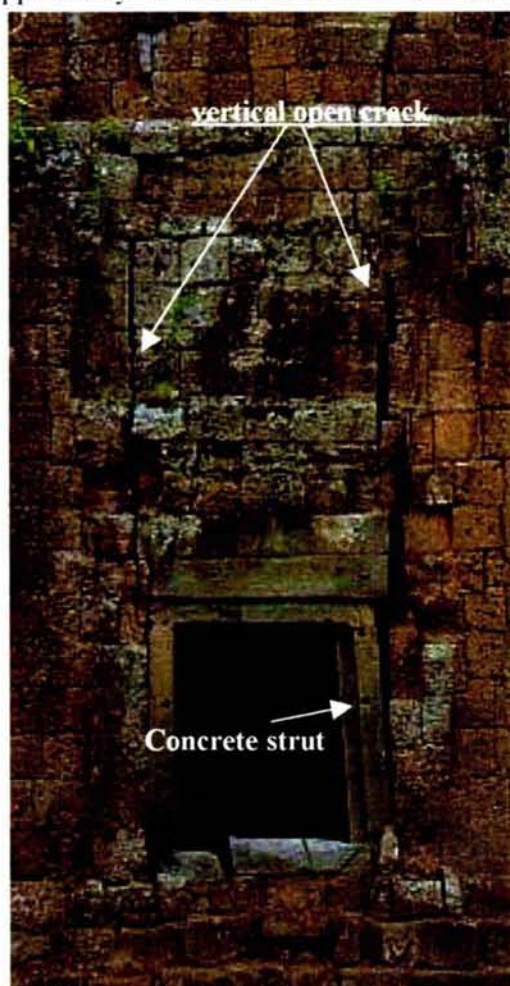
Photo 6-4 Vertical Opening above lintel

In Photo 6-4, two vertical open crack lines are extending from the each ends of lintel to the upper part of the 1<sup>st</sup> story. Whole weight of the laterite blocks between two cracks is supported by the lintel, which transmits this heavy load to the vertical columns. The both ends of the columns are further supported by horizontal bottom frame of stone beam as shown in Photo 6-4.

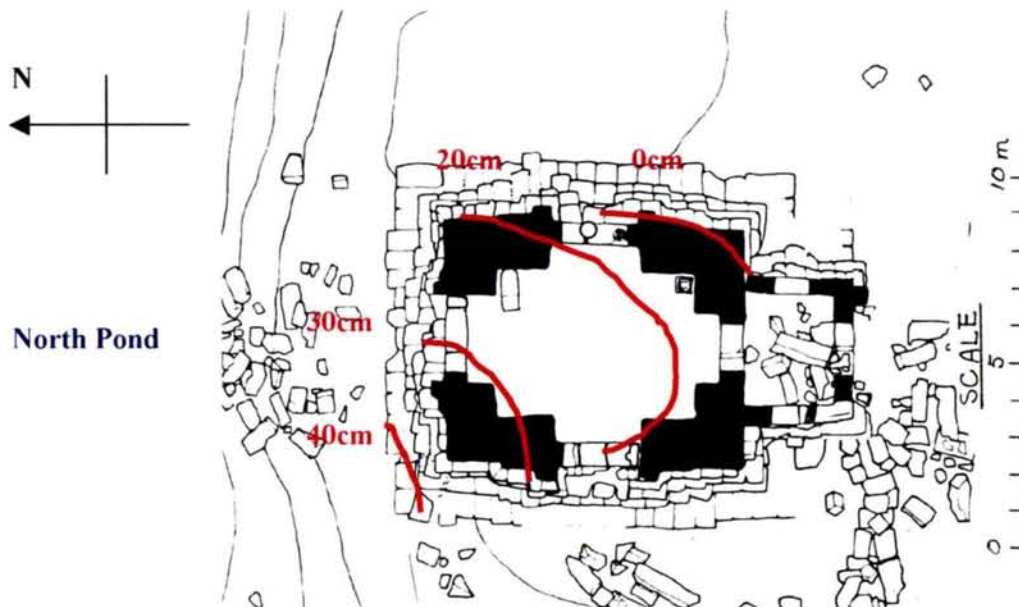
Fig.6-10 Estimated Relative settlement of N1, Prasat Suor Prat

Based upon these measurements, the inclinations of north and westwards are evaluated and drawn as equi-contour line of relative settlement contour lines as shown in Fig. 6-10.

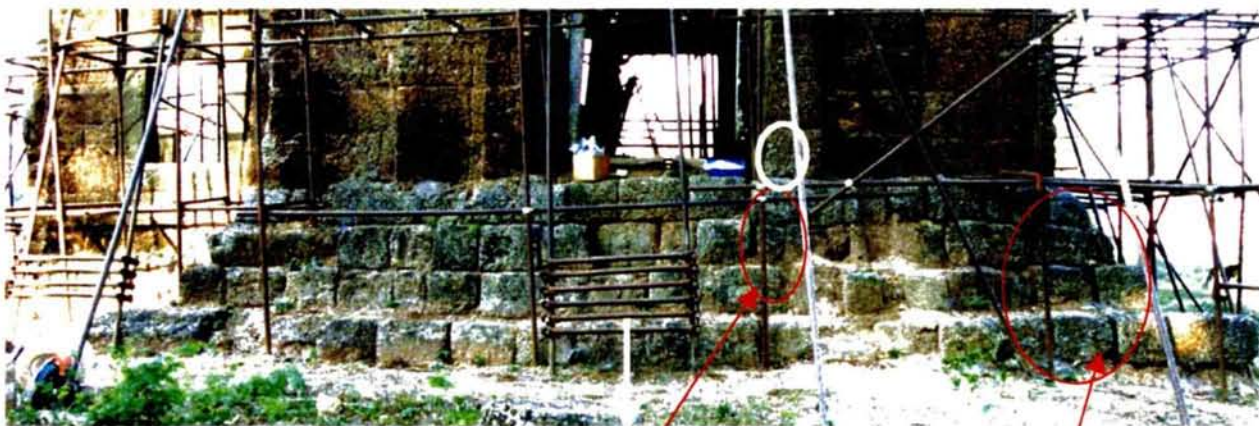
Photo 6-10 east foundation

This phenomenon of horizontal spreading of the foundation is confirmed at every faces of the tower except the south face, where the measurement is not possible. The horizontal spreading was caused by several reasons.
